TEST REPORT - EVALUATION
OF DU PONT LRU 488 AS A SEAT
SEAL MATERIAL IN THE MARQUARDT
R4D ENGINE VALVE

TMC Program 7208-3

This work was performed for the Jet Propulsion Laboratory,
California Institute of Technology, sponsored by the
National Aeronautics and Space Administration under
Contract NAS7-100.

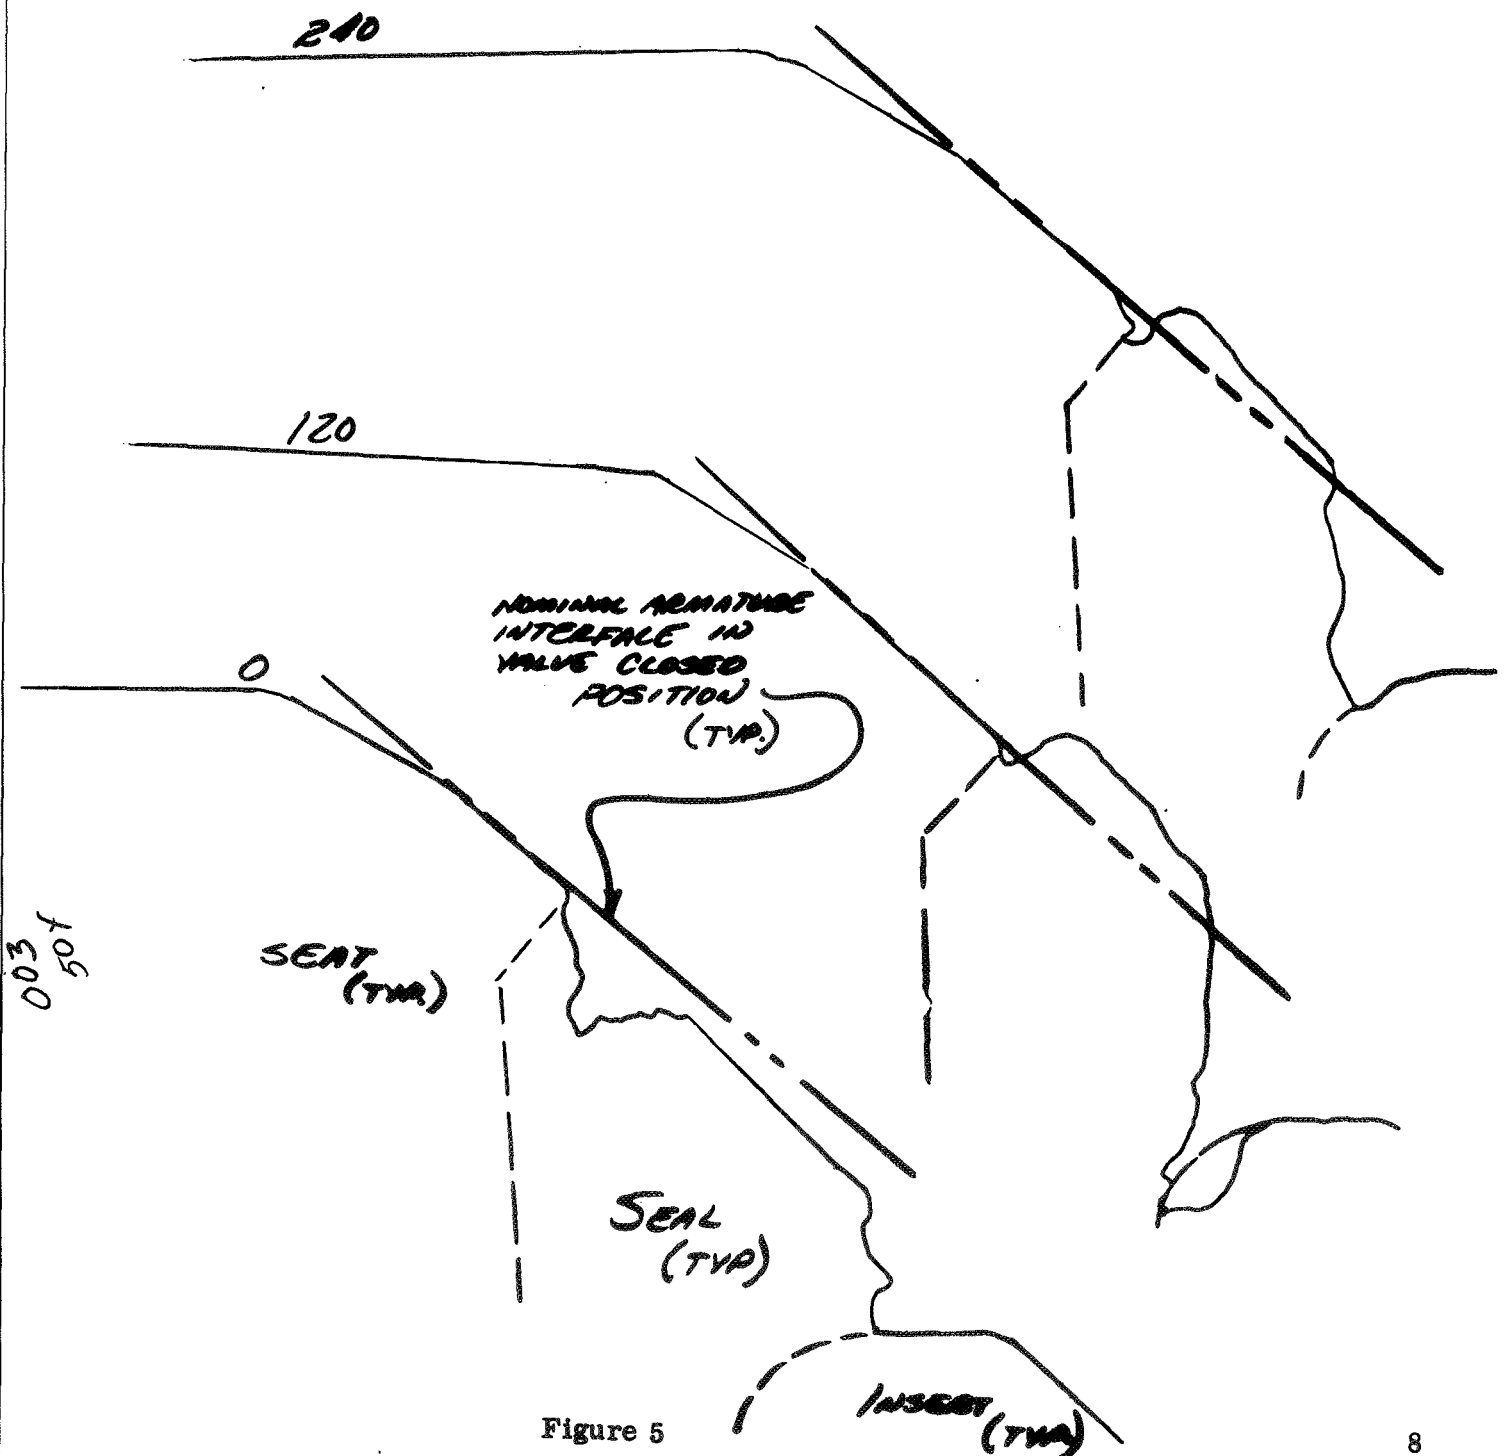
Figure 7

from 50 to 400 psig. The seat was reworked and reassembled with a new seal and insert (S/N 005 seal). The RTV mold again indicated an eccentric seal condition and potential inability to seal (Figure 7).

The undersize seal O.D. 's of all the seals was the origin of the eccentricity problems, since this diameter centers the seal in the counterbore of the insert during assembly. Other surfaces which tend to center the seal have inadequate "grip" to maintain concentricity during the assembly operation. Further attempts to reassemble S/N 1012 seat assembly were abandoned and an attempt to recover sealing characteristics was made by machining the metal immediately downstream of the seal, to produce a seal "proud" condition. A total of .0015" of material was removed from this surface and the seat assembled into the S/N 027 valve. Excessive leakage resulted at all pressures and further rework and testing of this valve assembly was suspended.

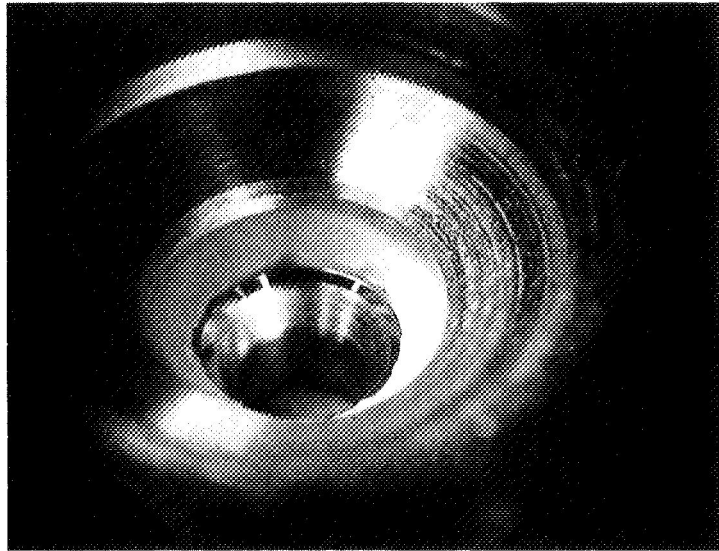
Figure 8 presents a photograph, at 12 x magnification, of the valve seat, after removal from the valve. The severe erosion of seal material, particularly at the downstream edge, is representative of the entire sealing area. In the upper right quadrant of the seal, a large section of seal, extending the full length of the sealing surface, has been eroded away.

The failure of the test unit seat seal to meet the test goal must be attributed to the seal design, rather than the material, since the flow decay phenomenon observed during initial acceptance testing, is apparently directly related to the ultimate degradation of the seal. Distortion of the seal, due to direct flow stream impingement on the seal, obstructed the normal flow annulus, causing flow decay. During high temperature testing when softening (or weakening) of the seal material occurred, still greater flow decay resulted. During the final valve cycle increment, an attempt was made to compensate for the flow decay by opening the throttling valve downstream of the test unit. The resultant increase in pressure drop across the test unit, in all likelihood, propagated the ultimate seal degradation. The origin of the seal failure, therefore, was the seal design rather than the material. To ensure a LRU 488 seal design of extended life cycle capability, the seal should be protected from flow stream impingement and should be of a design such that minimum structural capabilities are required of the seal material.

The wear properties of the material appear comparable to those of TFE. The erosion of the material which did result does not appear related to wear phenomenon in that large chunks of material are missing and appear to have been torn out in the normal flow direction

Seat Assembly from S/N 028 Valve After 10,000 Cycles

or sheared off by the impacting of the armature against the downstream metal surface when the seal was extruded toward the downstream by flow impingement. Seal interface surfaces which remain intact show no evidence of fretting and the mating armature surface exhibits no excessive smears of seal material.

- a. Obtain structural and thermal properties of the material and prepare a design, supported by a design analysis, of a valve seat which will result in overall valve performance comparable to that of the Marquardt R4D valve assembly.
- b. Fabricate evaluation seat designs and conduct an evaluation test program to assess cycle life, temperature, structural margin, and leakage characteristics, utilizing a R4D valve as a basic unit, modified to accommodate the selected seat/armature design configuration.
